**ADVANCED GAS TURBINE (AGT)  
TECHNOLOGY DEVELOPMENT PROJECT  
1986 ANNUAL REPORT**

Engineering Staff of  
Garrett Turbine Engine Company  
A Division of The Garrett Corporation

February 1987

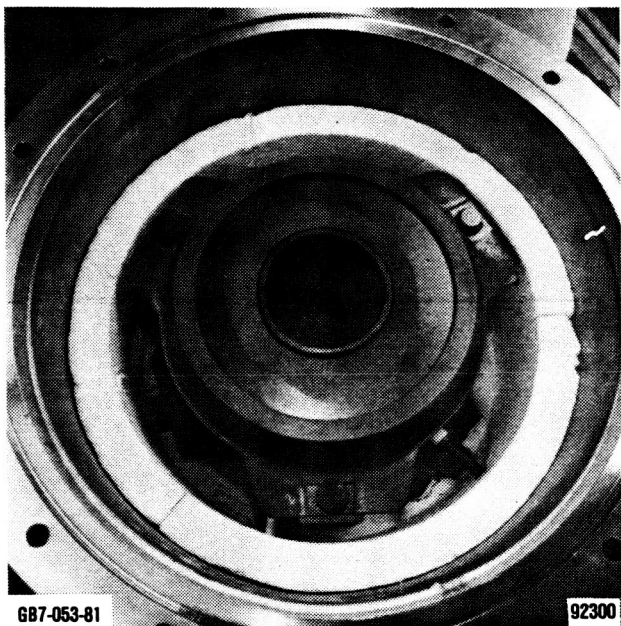
Figure 72. 2500F Stator Rig Shown with Ceramic Parts Assembled.

Rig modifications to allow extended 2500F operation were completed in early July 1985. Figure 71 shows the rig cross section. A modified SC201 turbine shroud and RBSN inner diffuser housing were used to provide a means of loading the ceramic hardware. The loading force is provided by external springs as shown. The assembled rig is shown in Figure 72.

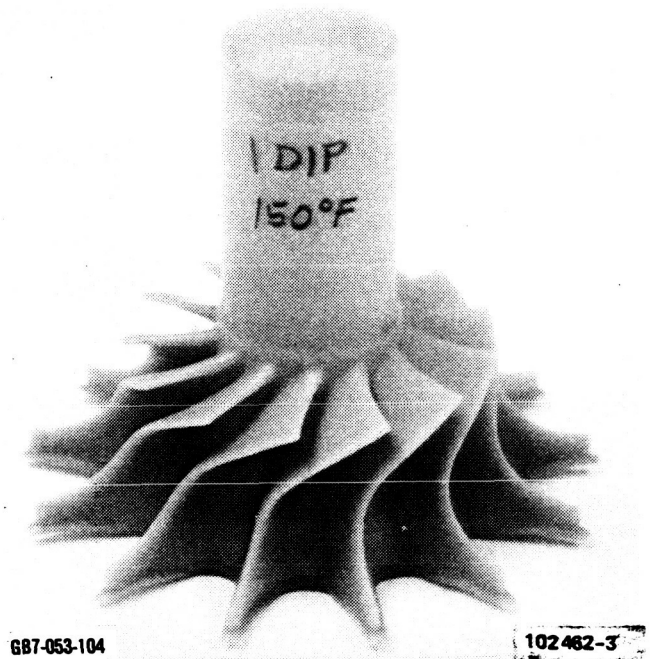
Figure 92. Single Dip Negative Wax.

Initial attempts to use single dip molds proved difficult (Figure 92). The wax molds were 70-80 grams lighter than previous molds. Unless slip was added to the mold slowly and carefully a leak would start at the mold/plaster interface, quickly draining the slip and

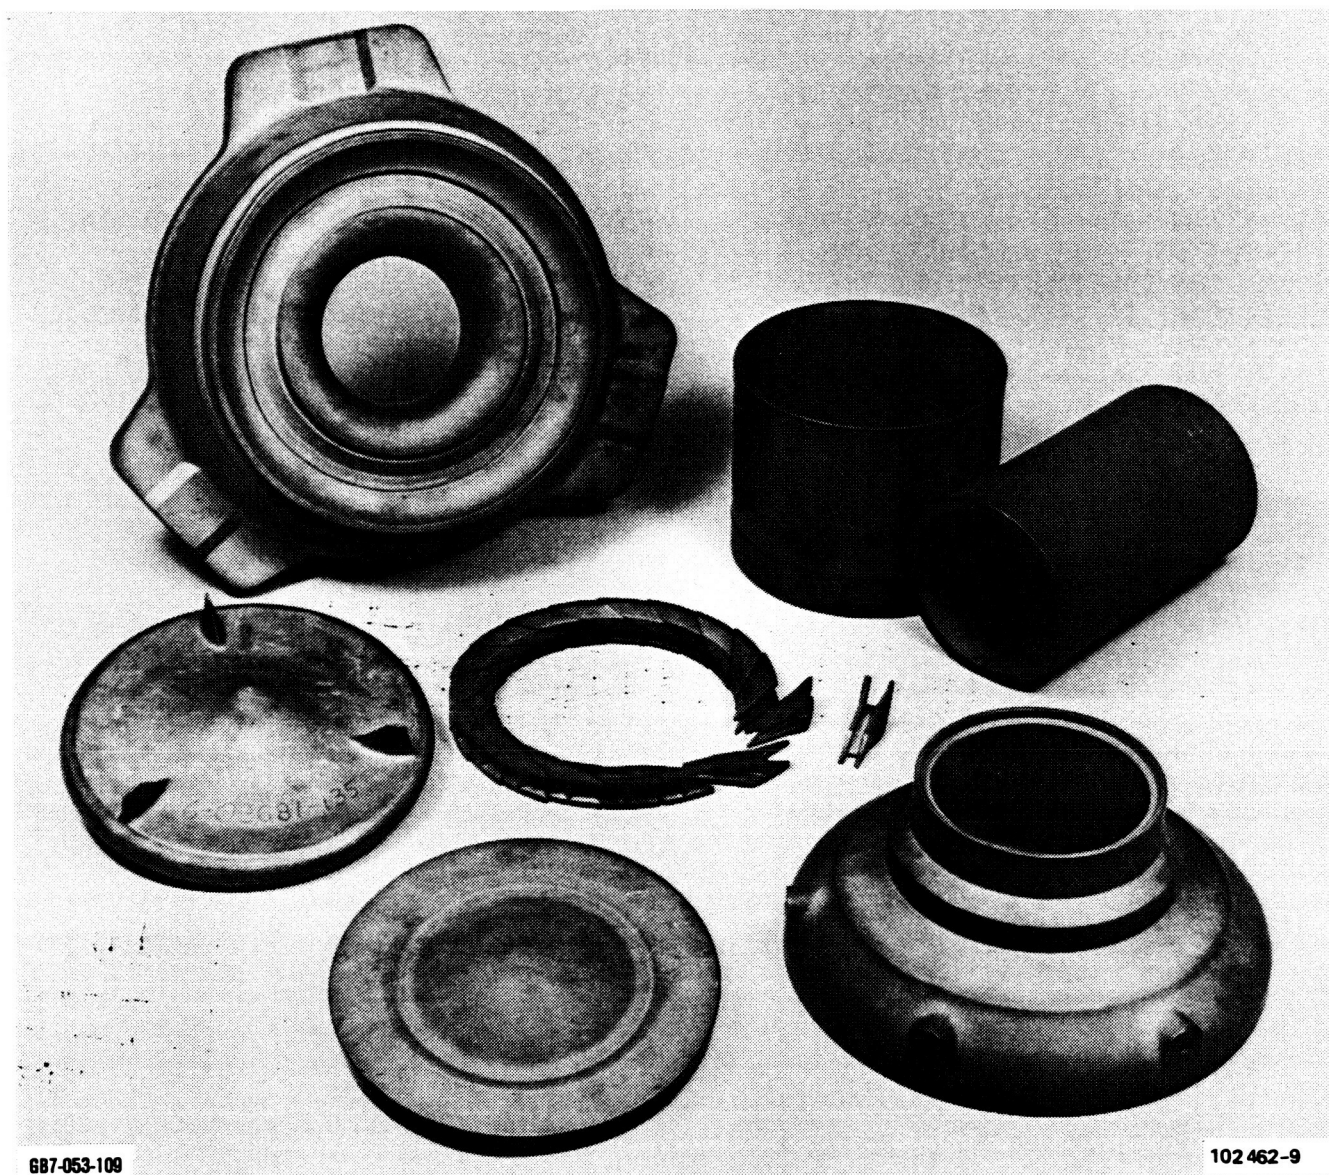
Figure 97. AGT101 Components for FY1986.

Work focussed primarily on four static structures made of sintered alpha silicon carbide: combustor liners, regenerator shields, combustor baffles and transition ducts (Figure 97). Early during the report period, the workscope included the development of dimensionally acceptable stator segments. This effort was terminated during the first half of this period due to unresolved dimensional problems and resources were reallocated on the fabrication of transition ducts as a higher priority component. A dual path fabrication approach was chosen for the transition duct. Isopressing and advanced green machining was continued to satisfy ongoing delivery requirements. In parallel, injection molding was initiated as a near net shape process and the preferred solution for fabricating a configuration with nonsymmetrical features. Injection molding was also the forming technique chosen for the combustor baffle. The remaining two components, combustor liner and regenerator shield were isopressed and green machined. All of the components were sintered on individual high temperature mandrels and then submitted for NDE in the as-fired state and after final grinding.

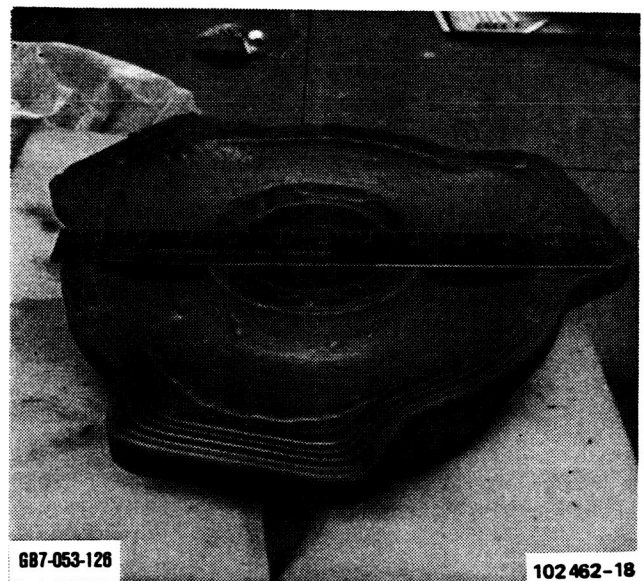
**Figure 114. Drain Cast Surface Showing Excess Stock.**

- h. Drain cast mold without rubber coated top center mandrel. Addition to plaster base insert with plaster cylinder registered to insert to bring level up to flange height. See Figures 113 and 114.

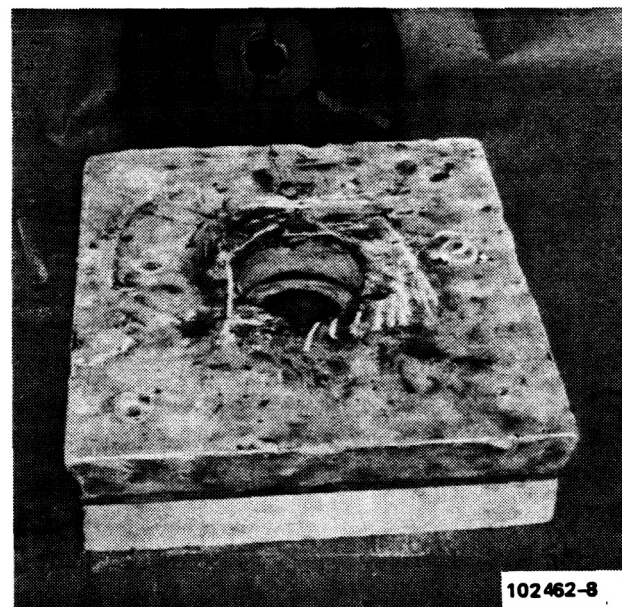
Figure 121. Drag Coated Mold Assembly Showing Metal Insert In Place.

- f. Cast mold with gate in drag side (mold inverted) and cope shellacked. See sketch Figure 120.
- g. Mold containing metal ring having a thickness which brings the top of the metal equal to the top of the O.D. of the casting to create new parting line for venting. See Figure 121.
